Manhole Inspection Summary

Manhole # S37QQ_013MH

Insp Date: **1/17/07 10:46 AM**

Location Address: **600 BARTLETT AVE**

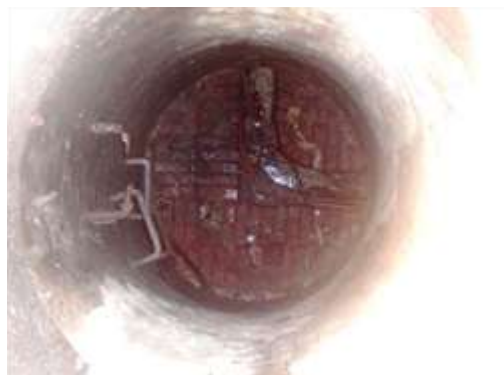
Top View

Corroded and missing steps. Evidence of surcharge - Bench debris.

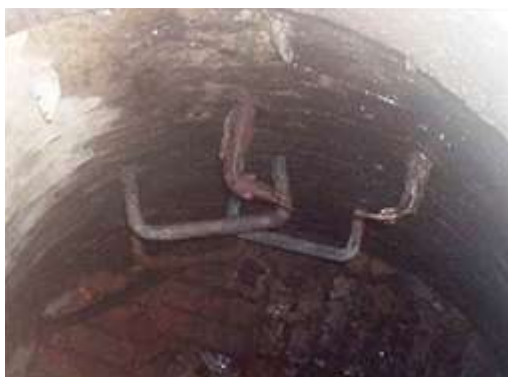
Defect

Frame leaks. Adjustment, corbel and barrel infiltration.

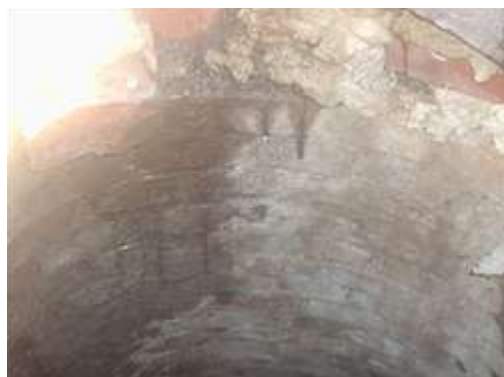
Defect

Frame leaks. Frame offset. Adjustment deterioration, loose brick and infiltration. Corbel infiltration.

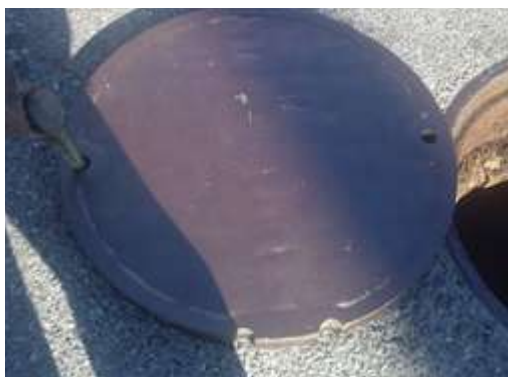
Defect

Worn lid.

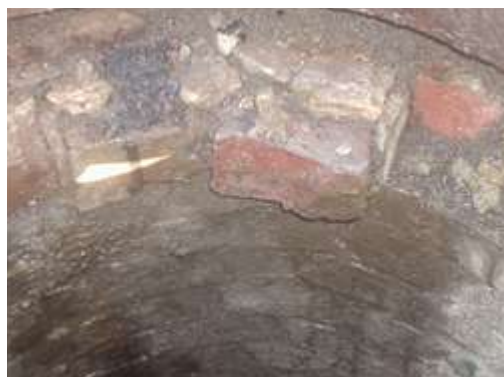
Defect

Frame leaks. Frame offset. Adjustment deterioration, loose brick and infiltration.

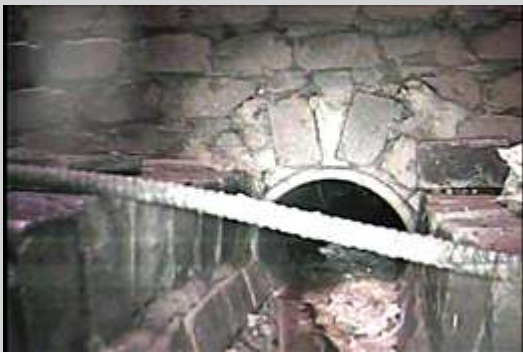
8 in. Circular Gravity Sewer Pipe Out @ 12 O'Clock

Barrel deterioration and infiltration. Channel deterioration.

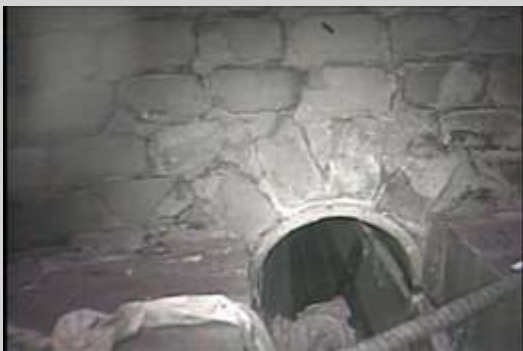
8 in. Circular Gravity Sewer Pipe In @ 3 O'Clock

Barrel deterioration and infiltration. Channel deterioration.
